REPEAT PHOTOGRAPHY: Methods and Applications in the Geological and Ecological Sciences

Chapter 8. Clearcutting, Reforestation, and the coming of the Interstate: Vermont's Photographic Record of Landscape Use and Response

Paul Bierman

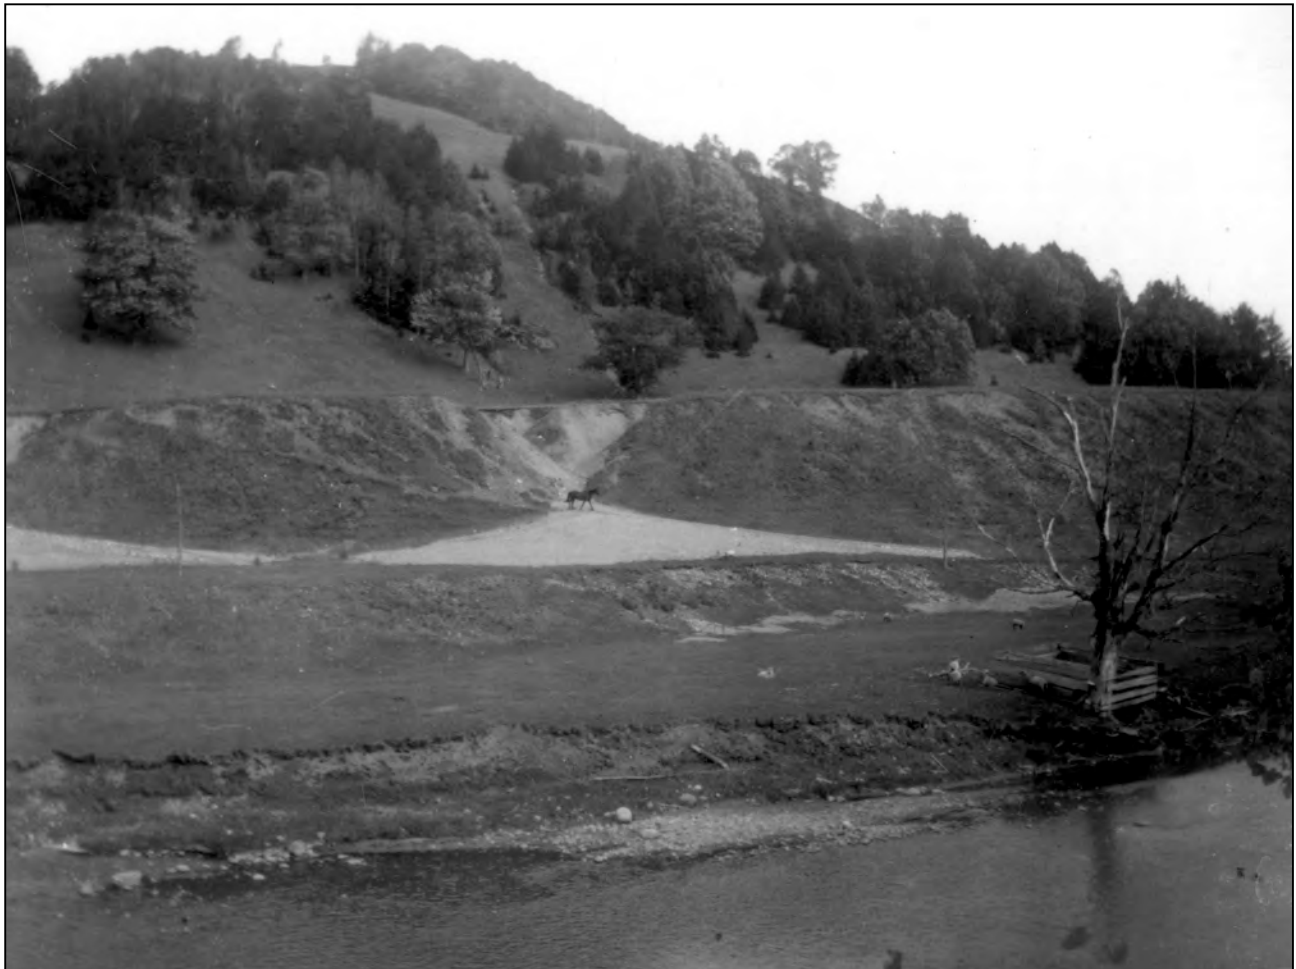
Figure 1. Deforestation catalyzed erosion by removing not only the trees but their roots which for millennia had bound weak soils on steep slopes (Bierman et al. 2005). In Tunbridge, Vermont, valley clearance exposed the steep slopes between sandy river terraces and led to gully erosion and small-scale landsliding. The sediment eroded from the steep slopes accumulated below on cone-shaped alluvial fans; the horse now stands on one of these fans. Trenching revealed the layers of sand and soil buried in such fans clearly shows a peak in sedimentation (and thus hillslope erosion) during settlement and post-settlement times (Bierman et al. 1997, Jennings et al. 2003). Image used by permission of the Vermont Historical Society. LS07574.

This regional-scale vegetation disturbance took place on a part of North America that had been continuously forested for more than 10,000 years since the climate warmed and the last of the continental glaciers had melted far back into interior Canada (Webb et al. 1987). In the uplands, forest clearance exposed thin soils developed on glacial till to the direct impact of heavy rainfall exacerbated by the hoofs of grazing animals, a pounding that compacted the soils and, as long as it continued, prevented re-growth of the forests. In the lowlands, sandy glacial outwash or river terraces left behind as streams readjusted after deglaciation, were stripped of trees. As stumps were pulled or roots rotted away, the strength imparted to the soil by those roots, termed effective cohesion, was lost (Bierman et al. 2005) and otherwise stable hillslopes failed in landslides and gullies (Figure 1).

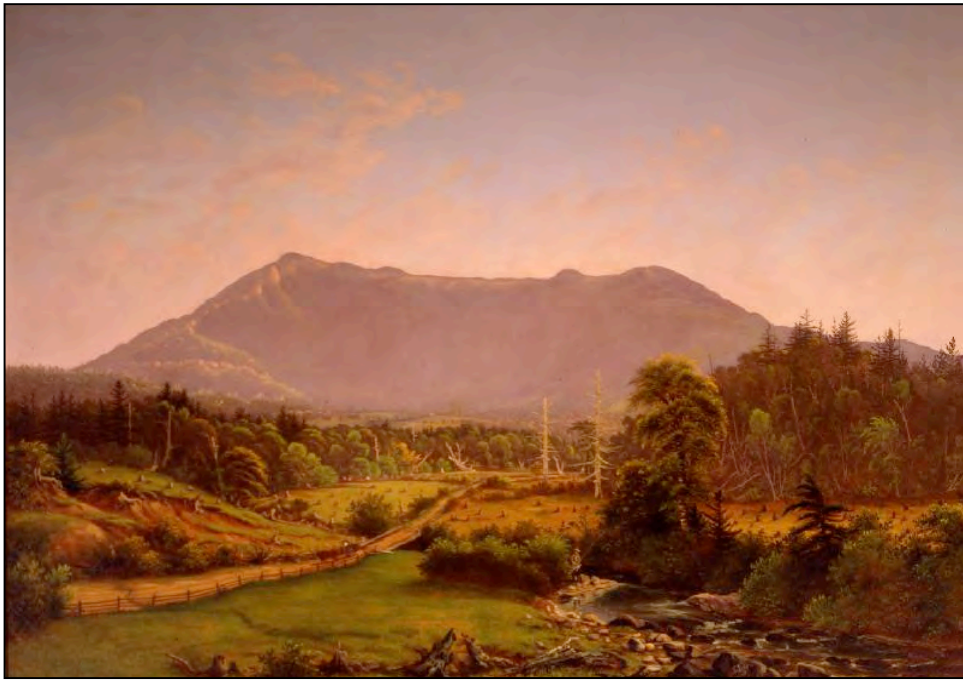
Figure 2. Local artists recorded the denuded landscape. Charles Heyde painted this view of Mount Mansfield and the Browns River in northwestern Vermont, c. 1857. He faithfully recorded stumps in the stream-side field and deep gullying that resulted from undercutting the toe of the adjacent hillslope. Image used by permission of the University of Vermont, Robert Hull Fleming Museum. LS09924.

The impact of land-use practices was not lost on those living in the mid-1800s. Artwork from the time clearly records landscape-scale responses to human actions including clear-cutting and road-building (Figure 2). With the popularization, during the 1850s, of photography as a medium for recording both human and landscape conditions, the deforested, pre-civil War, New England landscape was clearly and extensively documented (Figure 3). Such documentation was both intentional, e.g., in images where landscapes were the subject, and unintentional in images where the landscape was an incidental background to portraits, images of homes, and depictions of rural life (Figure 4). By 1882, George Perkins Marsh had documented the effects of unsustainable land management practices and decried in print the lack of concern over and the impact of human-induced erosion (Marsh 1882).

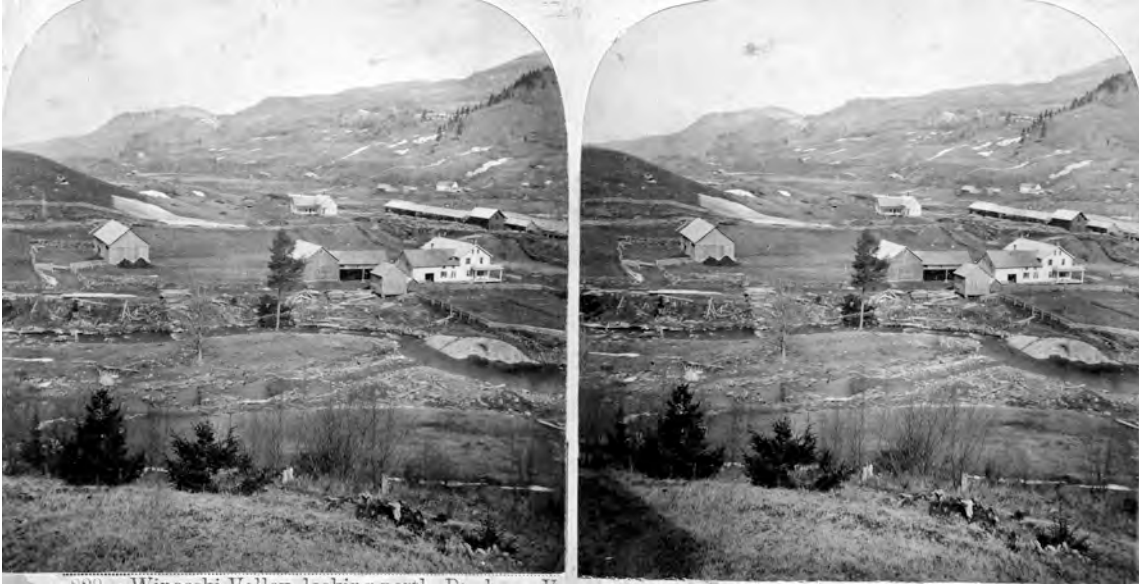
Figure 3. Early stereo photograph of the cleared Vermont landscape near the town of Duxbury, Vermont (c. 1875). Such images show the degree to which New England slopes were cleared of trees during much of the 1800s. Image used by permission of the University of Vermont, Bailey-Howe Library, Special Collections. LS03480.

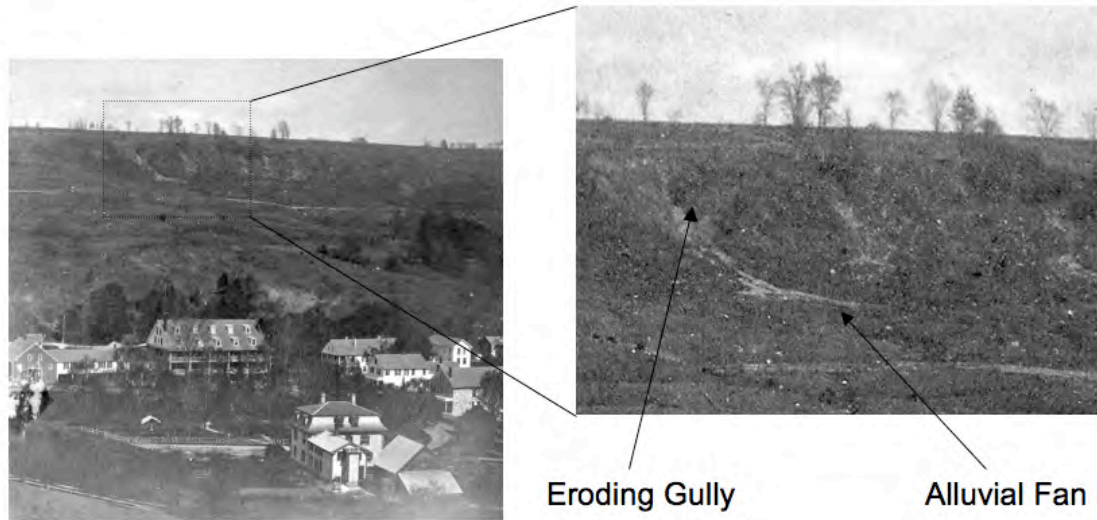
Figure 4. Image of hotel at Clarendon Springs, Vermont, c. 1880. Looking closely at the main image, one can see the barren slopes and clear evidence of gullying and deposition of sediment on an alluvial fan (see inset). In this image, erosion and sediment transport are not the subject but rather incidentally captured as part of the distant background.

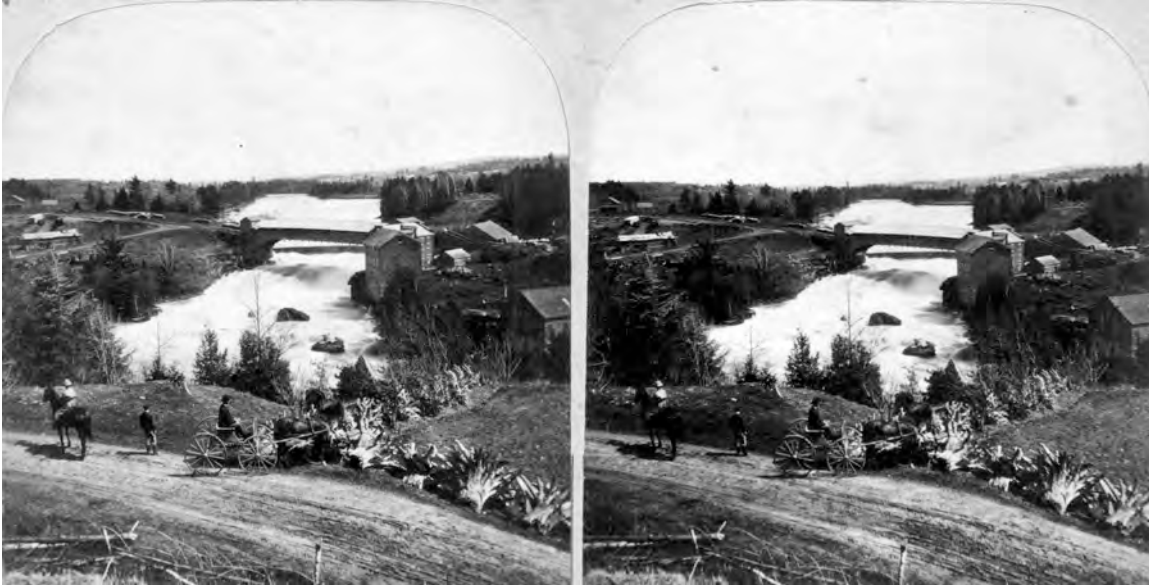
Figure 5. Stump fences were a means by which to re-use what otherwise would have been wasted resources (the stumps). Highgate Falls (c. 1880) is pictured along the Missisquoi River in northwestern Vermont. The stump fence defines an enclosure in the lower right of the image. Unstable, deforested slopes shown in the distance. Stereoview used by permission of the University of Vermont, Bailey-Howe Library, Special Collections. LS04684.

Initially, the settlers cleared these northern hardwood and softwood forests for agriculture, including both crops and grazing; later, higher elevation sites and those with poor soil were cleared for timber resources and for fuel (Cogbill et al. 2002). In some cases, stumps were pulled to clear fields (Figure 5); in other cases, the stumps, where

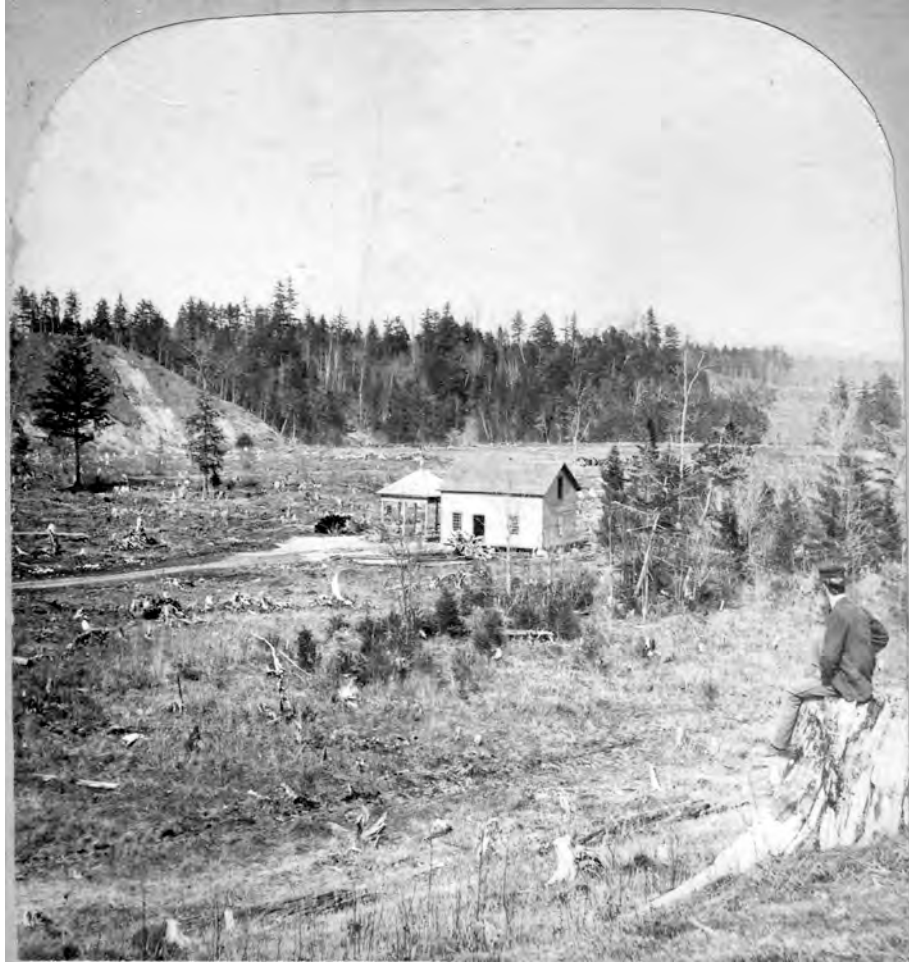
Figure 6. Historic stereoview of valley bottom clear-cut c. 1870, Champlain Spring, Highgate, Vermont. In the background are shallow planar landslides, hosted in fine-grain glacial deposits, on a cleared slope. These slides were likely catalyzed by loss of effective root strength after the slope was cleared (Bierman et al. 2005). In the middle ground, are many stumps and much slash, the remains of cutting second-growth timber. Spring house at the center of the image. Note the size of the stump that the man is sitting on; it remains from the old growth, pre-settlement forest that once covered Vermont lowlands like this. Stereoview used by permission of the University of Vermont, Bailey-Howe Library, Special Collections. LS03668.

timber was the object, not land clearance, the stumps were left in place (Figure 6).

Because photography came to Vermont after the old growth forests had been cleared, many of the images of active clearance from the late 1800s (such as Figure 6) show the cutting of second growth trees.

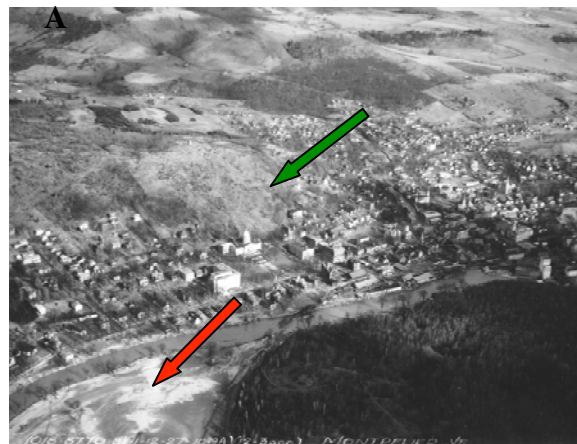
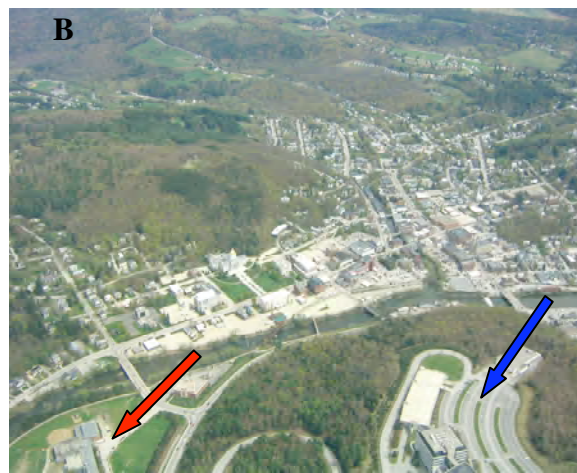
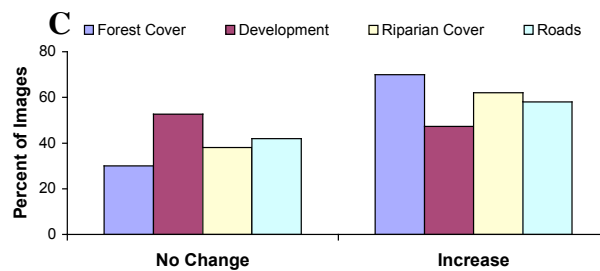
Figure 7. Rephotography of oblique imagery taken just after the 1927 flood shows specific examples (A and B) and the broader pattern of landscape change between 1927 and 2004. A. 1927 image of Montpelier, Vermont. B. 2004 image of Montpelier, Vermont. Green arrow shows area that has reforested. Red arrows show over bank deposits now covered by a high school. Blue arrow shows commercial development of once-wooded site. Note the lack of bridges (they have been washed out) in the older image. C. Characterization of images (n=67 pairs) showing percentage in which characteristics studied (forest cover, development, riparian cover, and roads) either remained similar (no change) or increased. Historic image (LS01429) used by permission of the University of Vermont, Bailey-Howe Library, Special Collections.

Modern rephotography of flood and post-flood images in the archive allows us to quantify changes that have occurred since 1927 (Figure 7). Examining the 67 pairs of aerial images, shows that between 1927 and 2004 forest cover increased in 70% of the images, new roads were built in almost 60%, development altered the landscape in almost 50%, and vegetation cover in riparian zones increased in over 60% of the images. These changes have differing effects on surface water hydrology with reforestation tending to reduce peak flows and storm flow volumes, whereas development and road building both tend to increase runoff and storm peaks (Dunne 1978).

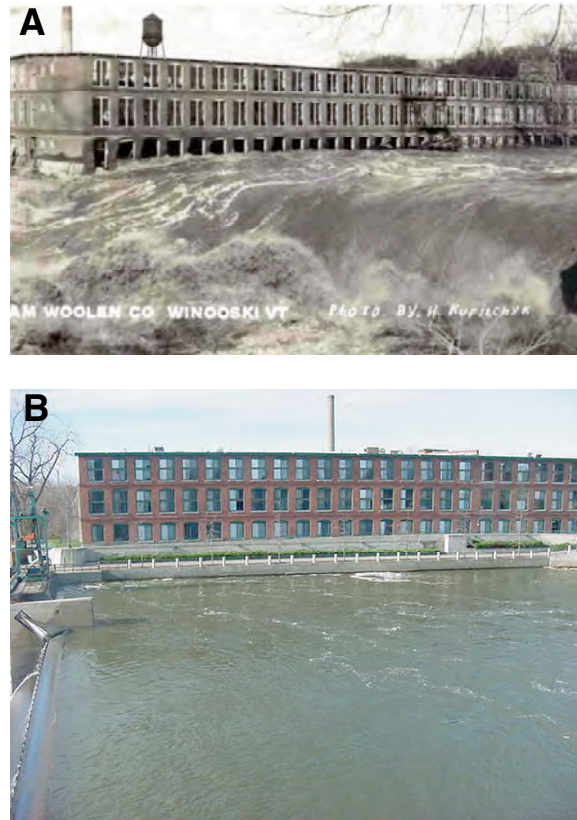
Figure 8. Imagery used to calculate Manning's n for a bedrock reach of the Winooski River. A. Image of woolen mill in Winooski, Vermont during high water of 1927 flood (118,000 cfs). Image used by permission the University of Vermont, Bailey-Howe Library, Special Collections. LS01132. B. Same mill from slightly different angle in summer 2003. The woolen mill is now an apartment complex. Note the considerably lower level of water (18,000 cfs). Level of windows used to match the imagery and determine river stage. Dam is present in both images but washed over in A.

More generalizable is the identification of flood heights from historic photographs, river stage being critical data for flood hazard evaluation. In bedrock channels, flood heights recorded by photographs can allow calculation of channel roughness coefficients (n), important for modeling flood flows with the Manning equation (Dunne 1978). Roughness coefficients of bedrock channels during exceptionally high flows are not well known (Wohl 1998, Reusser et al. 2004). In order to calculate n , we use USGS data to constrain peak flood discharge, survey data to determine channel geometry, and historical photographs to define a water level at the presumed flood peak (Figure 8). Combining the latter two data sources, we estimate the wetted perimeter at the time of flooding. We solve for n using values for all other variables in Manning's equation.

Assuming that the flood image (Figure 8) was taken at peak flow (118,000 cfs), Manning's n for this bedrock channel during the peak of 1927 flood was 0.020. This value is similar to a contemporary estimate (0.017) made at lower flow (18,000 cfs). Uncertainties in this approach include random errors in channel cross-section surveys and discharge estimates as well as potential underestimation of the wetted perimeter and

consequent over estimation of n if the image used to determine flow depth (and thus wetter perimeter) were not taken at peak flow. It is important to note that the example we give is of a bedrock reach, where we can reasonably assume that the channel geometry has not changed since the 1927 flood. Such an approach would fail in an alluvial system where channel scour during the flood and subsequent changes from later events would alter channel geometry as shown in the section that follows.

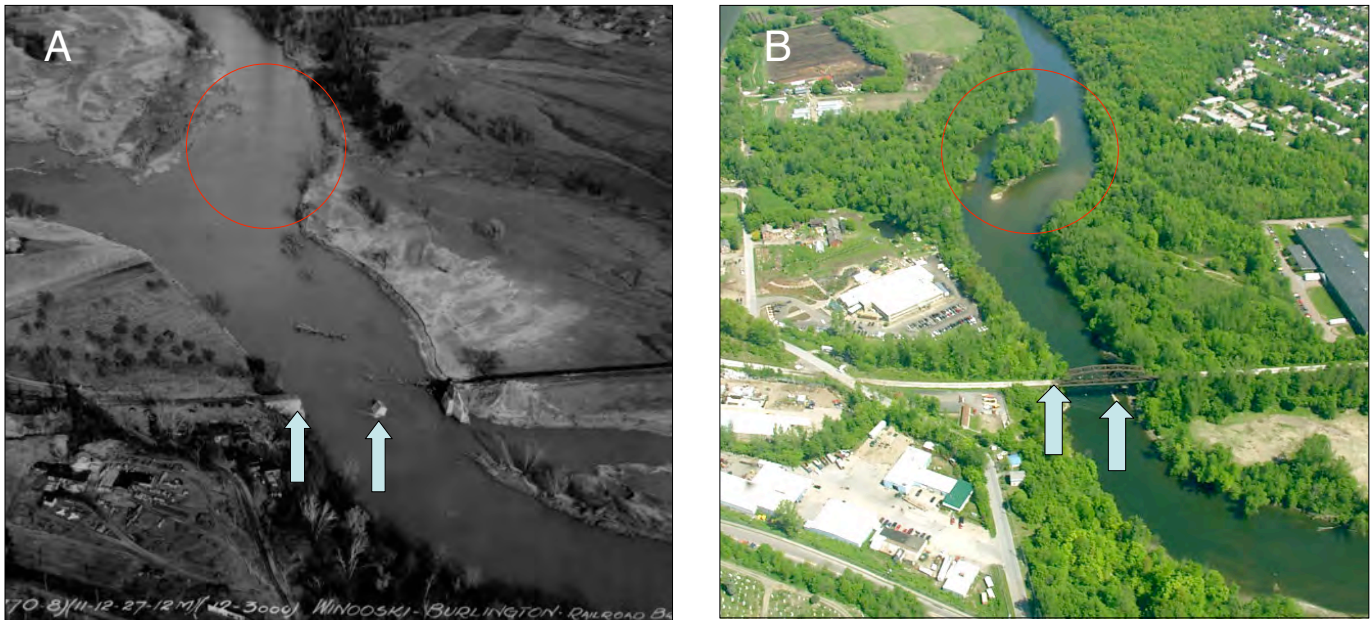
Figure 9. The earliest wide spread aerial photography of Vermont was taken by the Army Air Corps within days of the devastating 1927 flood. A 1927 image (A), taken 8 days after the flood, is juxtaposed with a 2004 image of the same view (B). There are many differences between the two images but the most striking is the magnitude of channel change, specifically the narrowing of the channel near the bridge (same abutments marked by arrows in both images) and the reappearance of the island, farther north (circled). Extensive, light colored sandy splay deposits are visible in the 1927 image. Image used by permission of the University of Vermont, Bailey-Howe Library, Special Collections. LS01418.

Rephotography of the oblique aerial imagery from the 1927 flood indicated that some parts of the river systems were more susceptible to change than others. For example, the Winooski River forms the boundary between the cities of Winooski and Burlington. Here, the river has just become alluvial, passing over the last set of bedrock falls. For the next ~20 river kilometers, this major river flows across a broad alluvial lowland, termed the Intervale, before emptying into Lake Champlain.

Although several image pairs showed significant changes in river channel morphology in the 77 years between the original 1927 images and the rephotography done in 2004, one image pair (Figure 9) was located in an area where there mapping and other historic imagery provided more than a 100 year record of channel change over time (Figure 10). Analysis of all the records (Figure 10), catalyzed by the observations made on the image pair (Figure 9) demonstrated that the flood of 1927 removed a mid-channel island (which has since reappeared) but that the channel narrowing documented in the paired imagery (Figure 9) had been on-going since at least 1910 (Figure 11).

One can speculate on the why the Winooski River (as pictured in Figure 9) responded the

way it did to changes in watershed conditions as Vermont was settled and cleared by westerners. Field reconnaissance suggests that the channel narrowing observed near the bridge (Figure 11) is the result of incision over time. This incision has left terraces composed of historic sediment several meters above the channel and beyond what is today bankful stage. Trenching studies elsewhere in the Winooski Intervale indicate that one to as much as several meters of historic alluvium were deposited during the 1800s after the Winooski watershed was deforested (Thomas). Presumably, this widespread alluvial deposition reflects increased sediment supply from the cleared and eroding uplands (Bierman et al. 1997). Map analysis indicated that the Winooski River delta prograded into Lake Champlain in the mid to late 1800s before sediment yields dropped (due to reforestation) and longshore drift moved much of the sediment away from the river mouth (Severson 1991). This dynamic landscape history and fluvial response can be represented graphically (Figure 12).

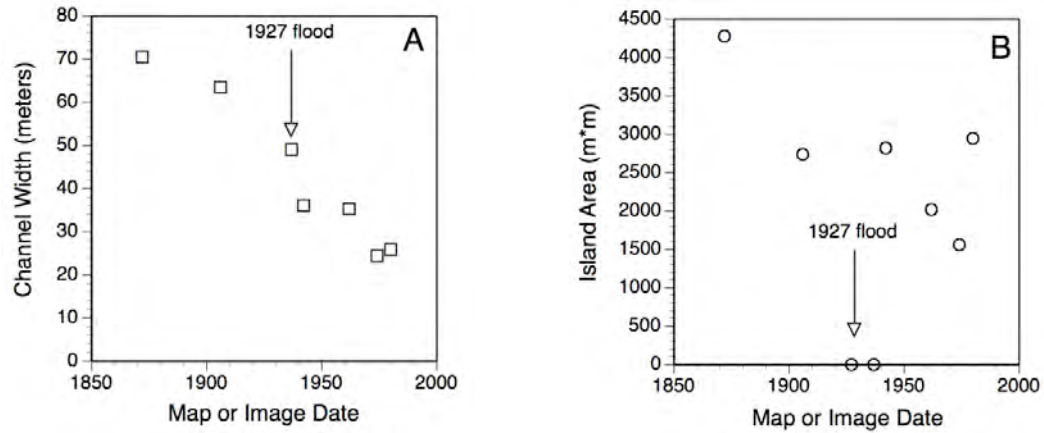
Figure 11. Using both aerial photographic imagery and a variety of map products demonstrate that the channel of the Winooski River at the location shown in Figure 9 has narrowed over time (A). The adjacent island, which existed prior to its removal by the flood of 1927, had reappeared by 1948 (B).

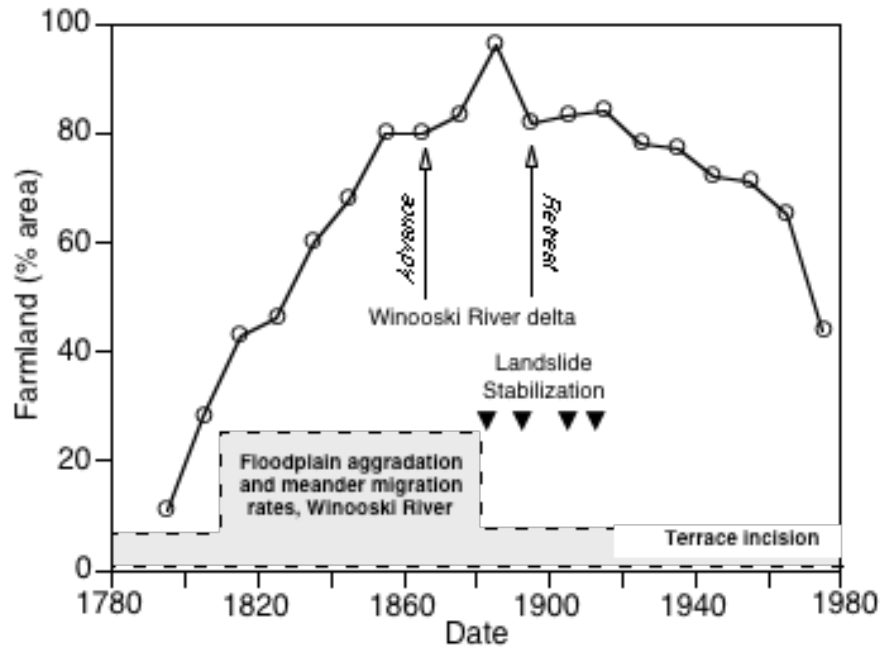
Figure 12. Graph summarizing Vermont landscape history and fluvial response. Percent farmland for Chittenden County, Vermont over time, is shown by open circles connected by a solid line. Advance and retreat of the Winooski River delta into Lake Champlain (Severson 1991). Timing of landslide stabilization in tributary of the Winooski River determined by coring trees occupying landslide scars (Baldwin et al. 1995). Timing of floodplain aggradation (Thomas). Modified from figure first presented in Bierman et al. (1997).

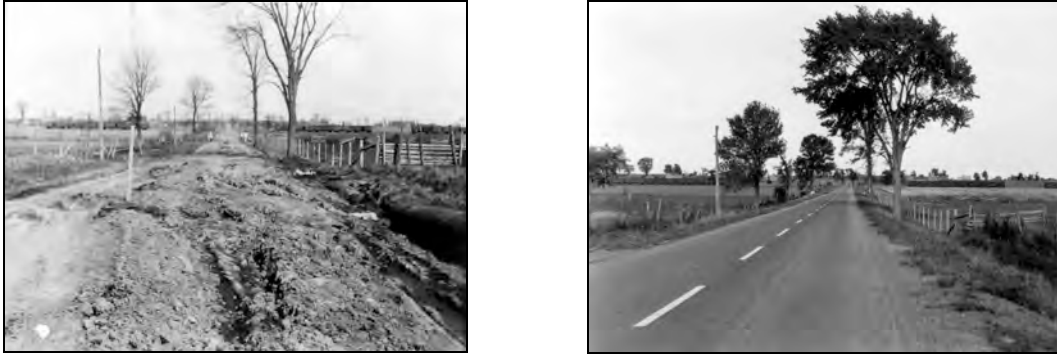
Figure 13. Photographers hired by the State of Vermont documented road reconstruction projects that changed the face of the state and enabled rapid movement by automobile. These views are from Alburg, Vermont and were taken in 1937. A. Muddy rutted road before reconstruction and paving. Same road after reconstruction. Note that earthmoving activities here are quite limited; paving is the greatest change. LS08600. Used by permission of the Vermont State Archives.

guardrails were added, bridges rebuilt, and drainages rerouted (Figure 13). Presumably these images were used to show the public the effectiveness of their tax dollars. This was rephotography on a short timescale but an approach that documented significant and rapid changes that affected both the built and natural environment. The resulting pairs of images show a landscape in transition in response to the growing importance of the automobile.

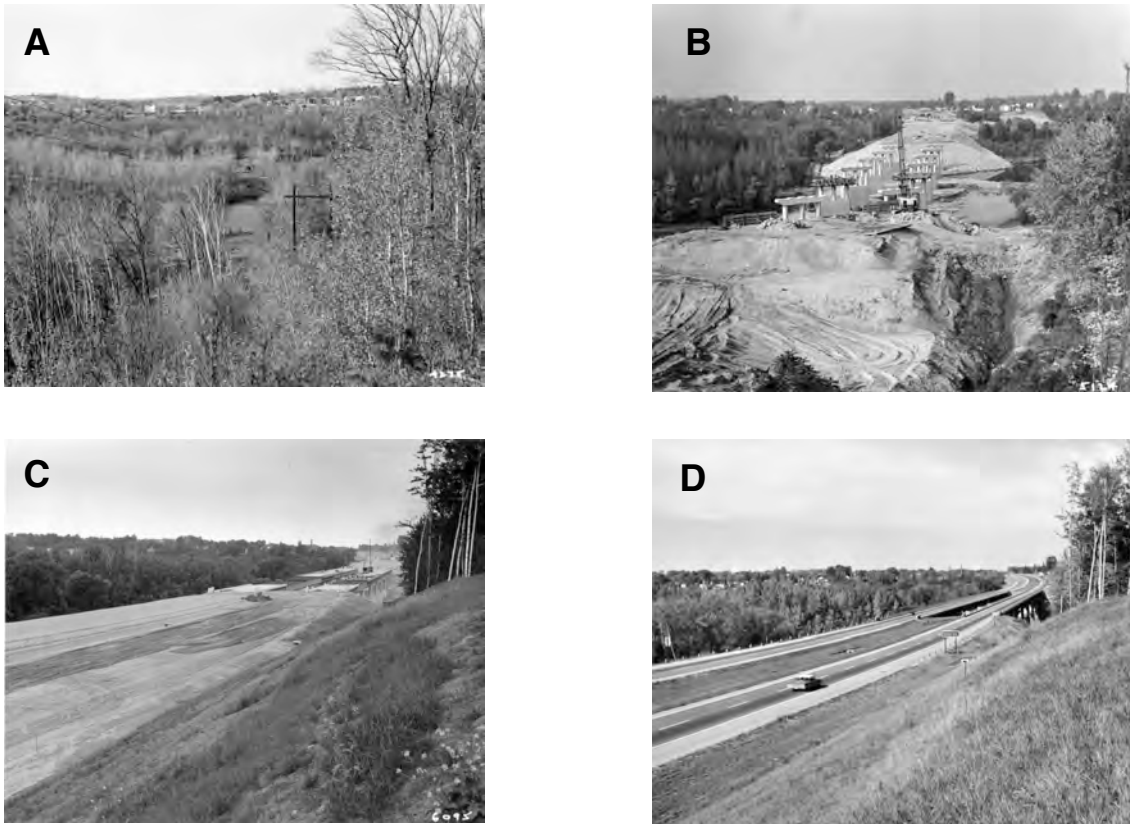
Figure 15. The coming of the interstate highway system fundamentally changed the Vermont landscape. This series of four images taken at the same site over a period for 3 years by Vermont Agency of Transportation photographer, Donald Wiedenmayer, shows the preconstruction view of the site (A), the construction of a bridge over the Winooski River about 10 km upstream from Lake Champlain (B), the grading of the roadbed (C) and the completed roadway (D). Both the channel-bordering slope and the riparian zone have been completely remolded by construction. The channel is now obstructed by bridge supports and the grass and wooded riparian zone has been replaced by stone rip-rap. Images used by permission of the Vermont State Archives. LS00376.

Within Wiedenmayer's work are sets of images that were reshoot over several years from exactly the same locations. Some of these image sets (e.g., Figure 15) contain up to four images. These image sets clearly show the scale and impact of Interstate highway construction on the landscape. Entire slopes are moved, rivers are dammed, banks are rip-rapped and the hydrology is radically changed. Our experience is that presentation of these images sets in sequence is most effective at awakening audiences to the immensity of earth movement and landscape change occasioned by highway construction. People who lived through the decades it took to build the highways tend to view the change as gradual. Those whose knowledge of the landscape post-dates highway construction are typically shocked at the scale of change. It appears that such sequential rephotography of massive earth moving projects has the potential to inform and perhaps sway public opinion.
