The 1927 Flood

**Repeat Photography Documents
Landscape Change 75 Years After An
Horrendous Flood**

**By Elizabeth Stanley-Mann,
UVM 2005**

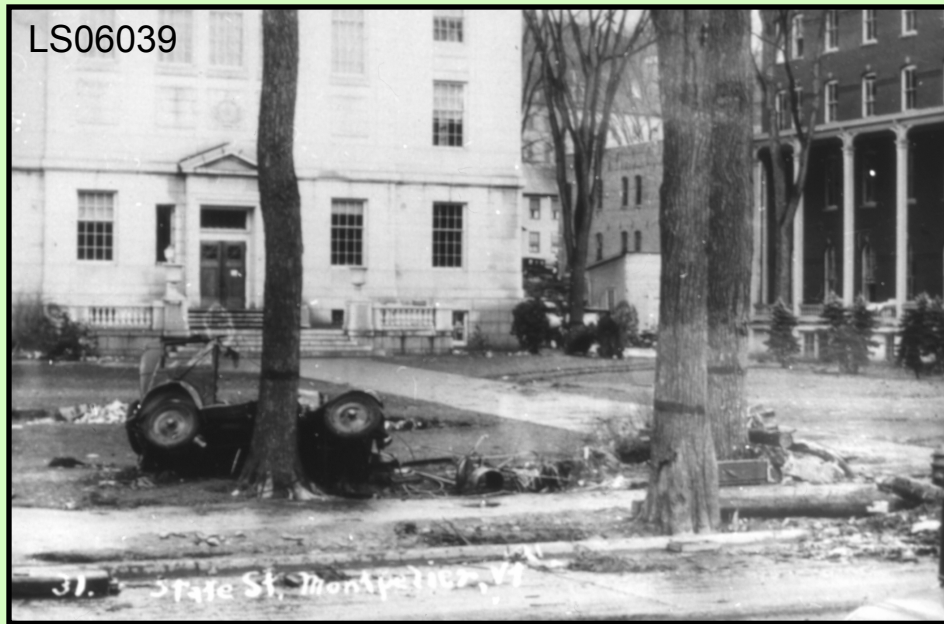
Montpelier, 1927. Photo shows flood damage at state capitol. Note variation in color on tree trunks indicating height of flood waters

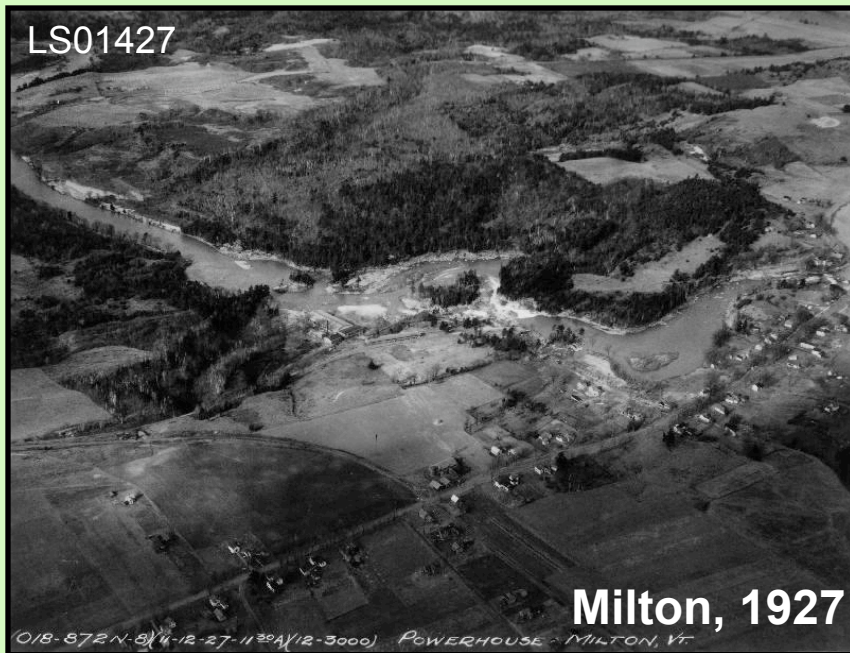
In the days after the flood, the federal government commissioned a flyover of the Winooski, White, Black, and Lamoille Rivers. They documented the flood damage with ninety aerial photographs, sixty-eight of which are displayed on the Landscape Change Website. (<http://www.uvm.edu/landscape>)

These photos accurately document the destructive forces of the flood. They also show land use and development in 1927 Vermont.

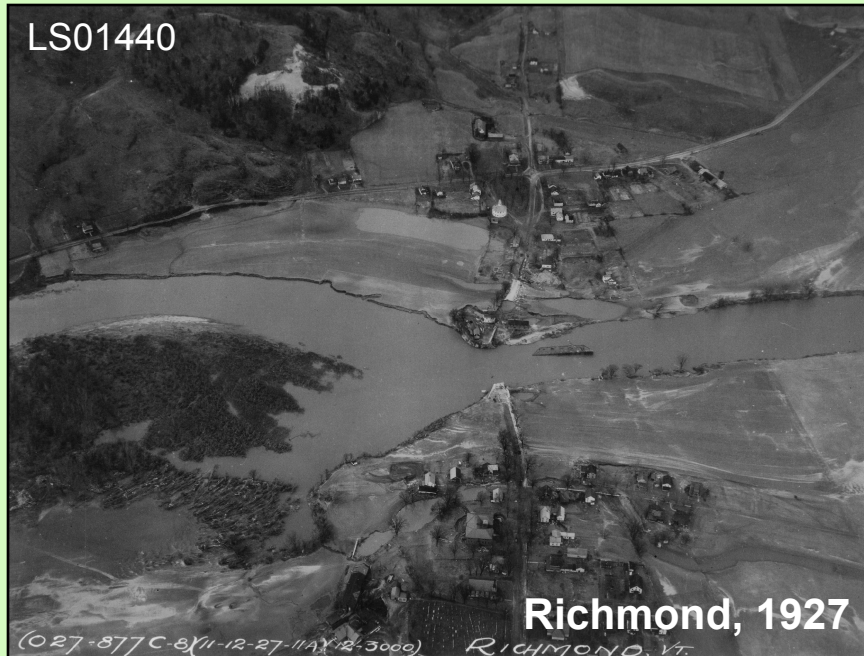
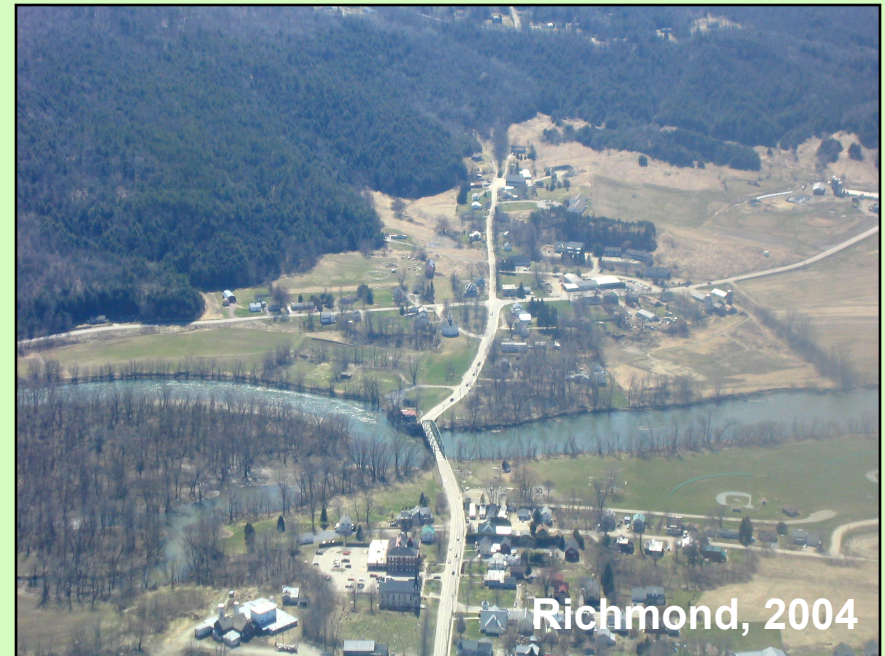
Channel Change: Width

This image pair shows the narrowing over time of the river channel since the 1927 flood. On the whole the river channels represented in the photographs have not changed appreciably, but approximately 12% have narrowed and 5% have widened.

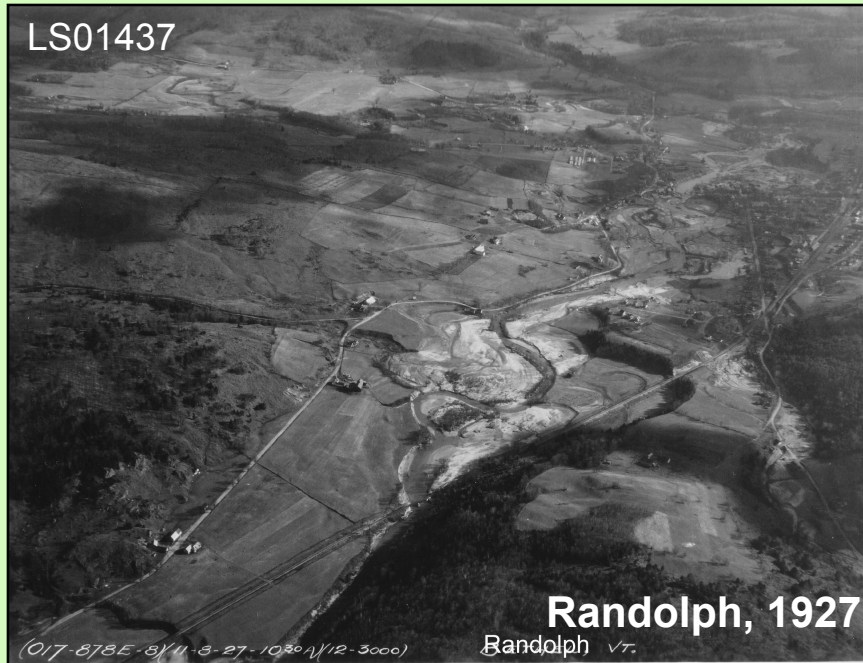
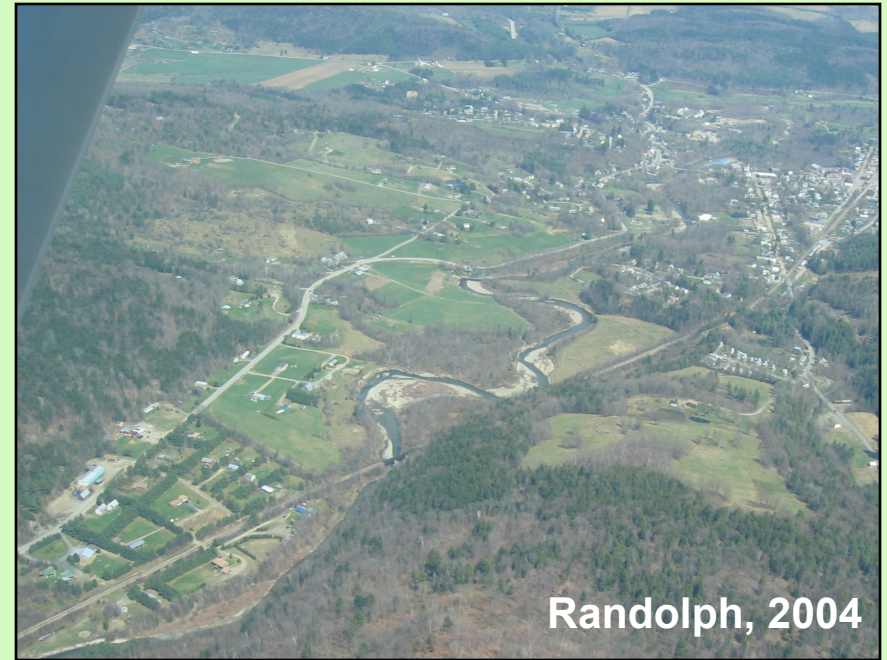
Channel Change: Route

This set of images represents the changes in the route of the Stevens Branch over the last 77 years. In general most photographs showed little change in channel route, 25% showed some change, and 2% showed a lot of change.

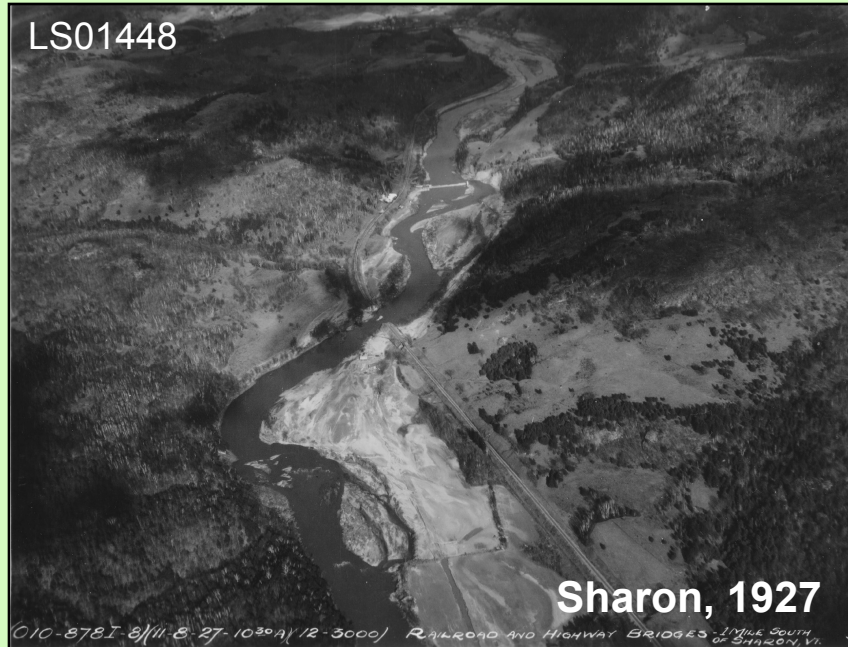
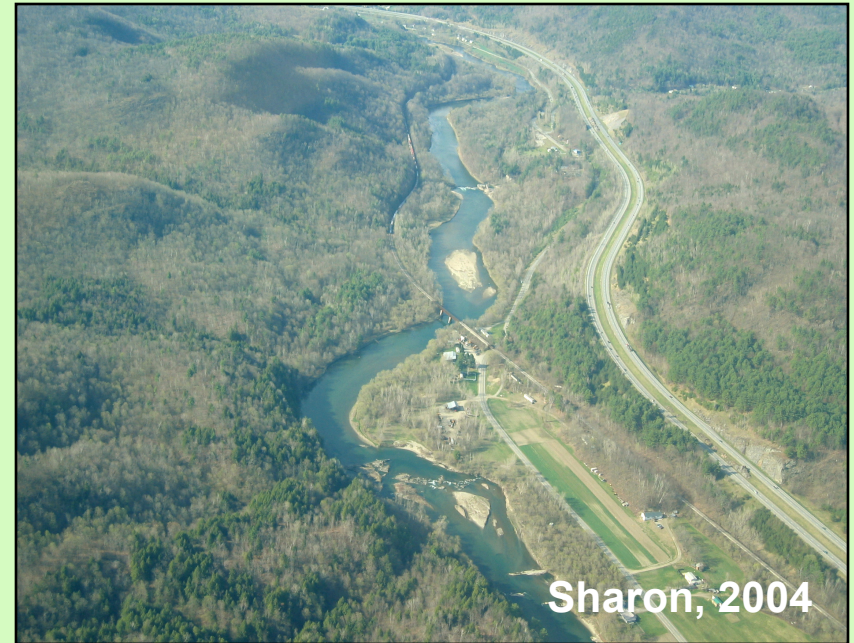
Channel Change: Mid-Channel Island

While many photos did not have mid-channel islands in them, those that did show that many were created after the flood. Perhaps high flows eroded the many islands that slowly came back over time.

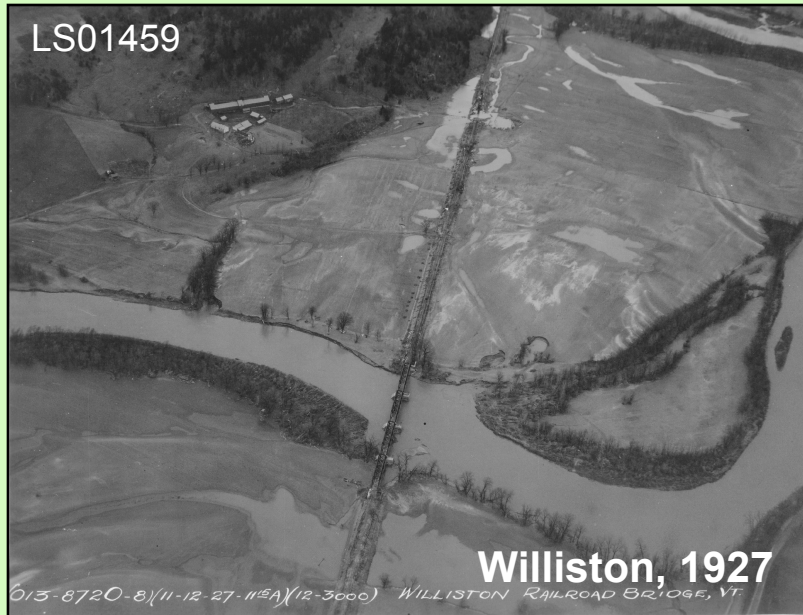
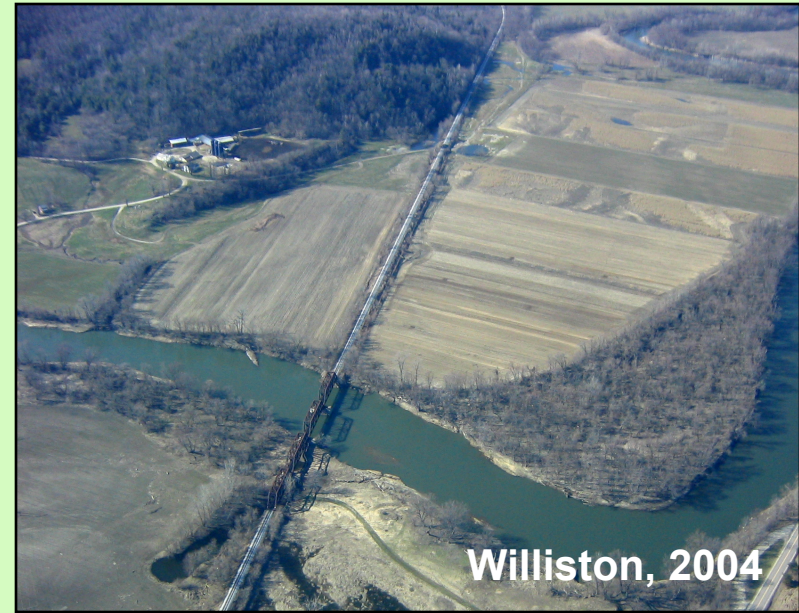
Channel Change: Abandoned Oxbows

This photo pair shows an oxbow abandoned before the flood. This photo also shows the magnitude of flood waters as the fields throughout the photo were washed over. Very few photos had abandoned oxbows, those that did showed approximately 5% abandoned pre-1927, and 7% abandoned post-1927.

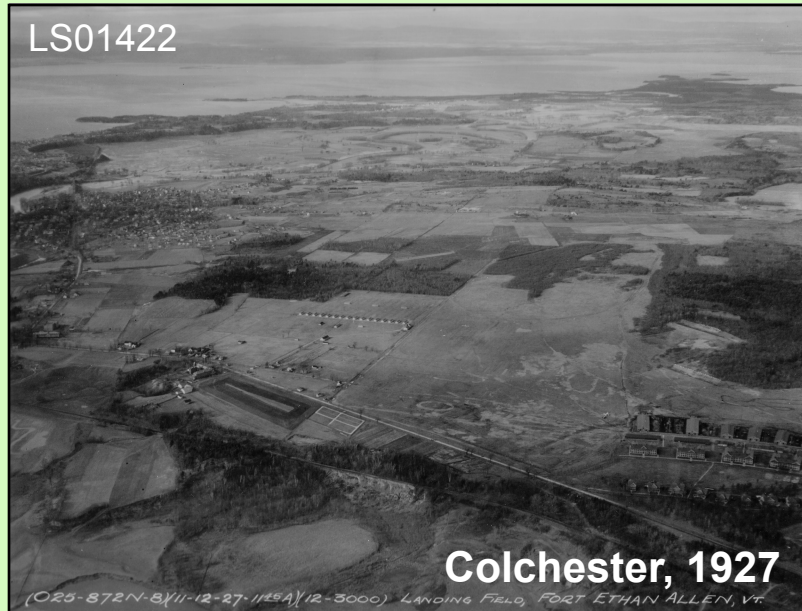
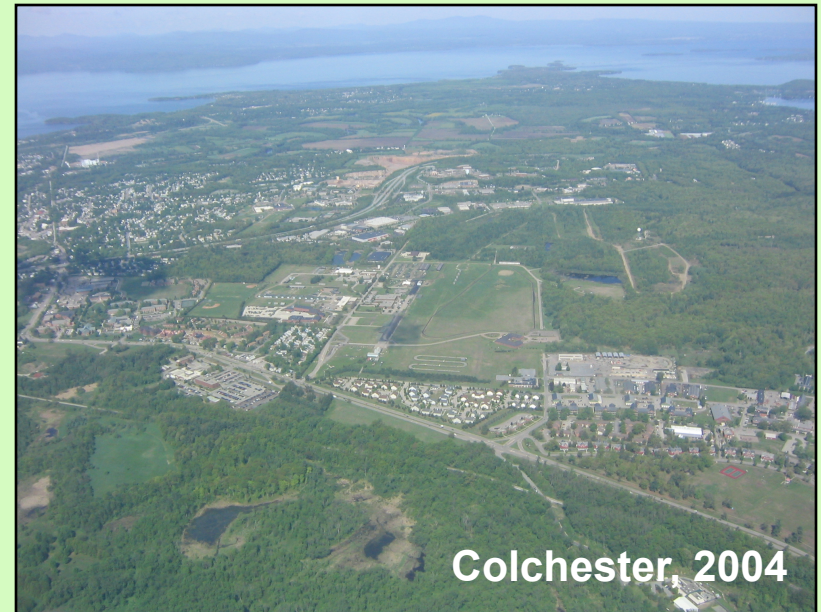
Reforestation

Photo pair shows reforestation in the greater Burlington area. Lake Champlain is in the background, and an abandoned oxbow is in the foreground of the current photo. Winooski River.

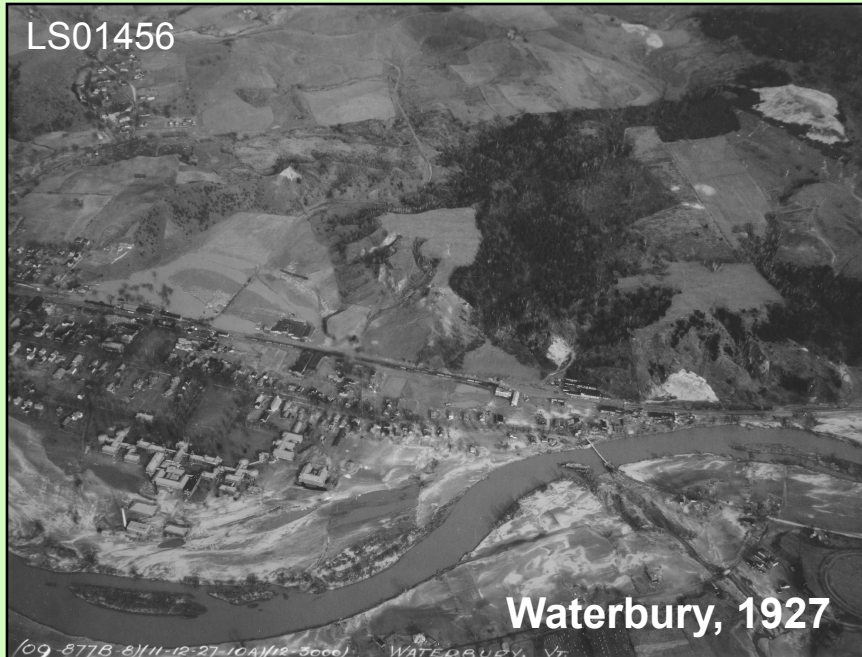
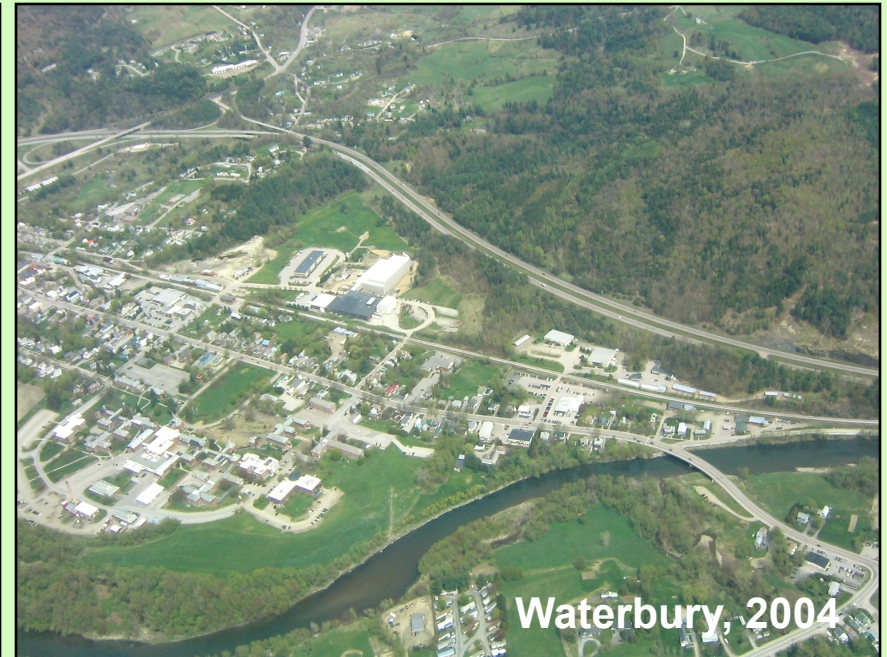
Development

This set of photos shows the development that has taken place over the last 77 years. Note bare, eroding ground in upper right of historic photo. Winooski River.

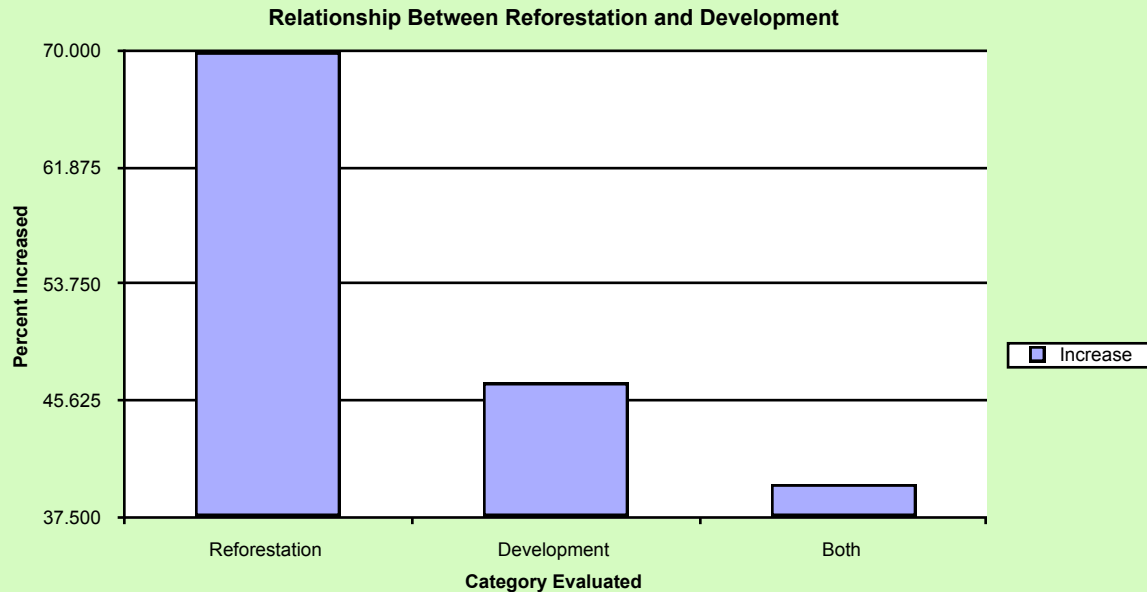
Reforestation & Development

This graph shows the relationship between reforestation and development seen through the 1927 flood aerials. Over the last 77 years both forest cover and development have increased.

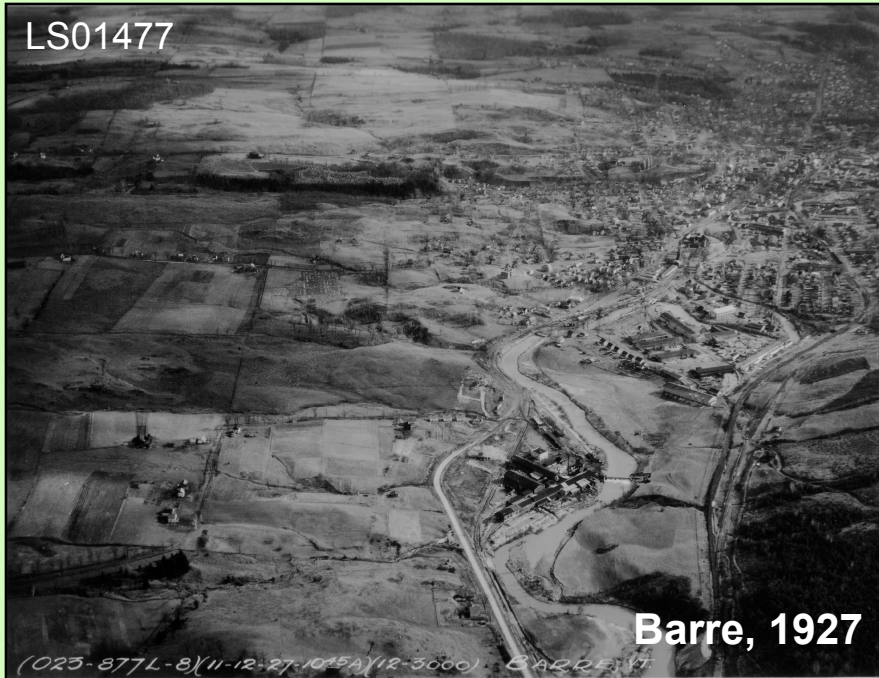
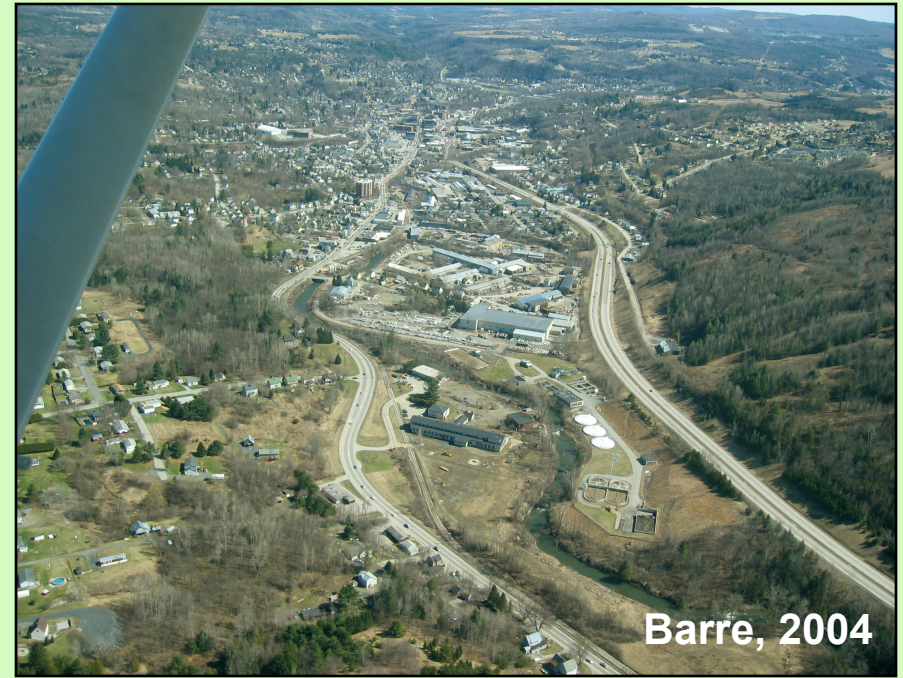
Road Building

Considerable road building has taken place in the last century in Vermont. This includes the widening of current roads, the creation of new state routes and the building of Interstate 89 (at right). Winooski River.

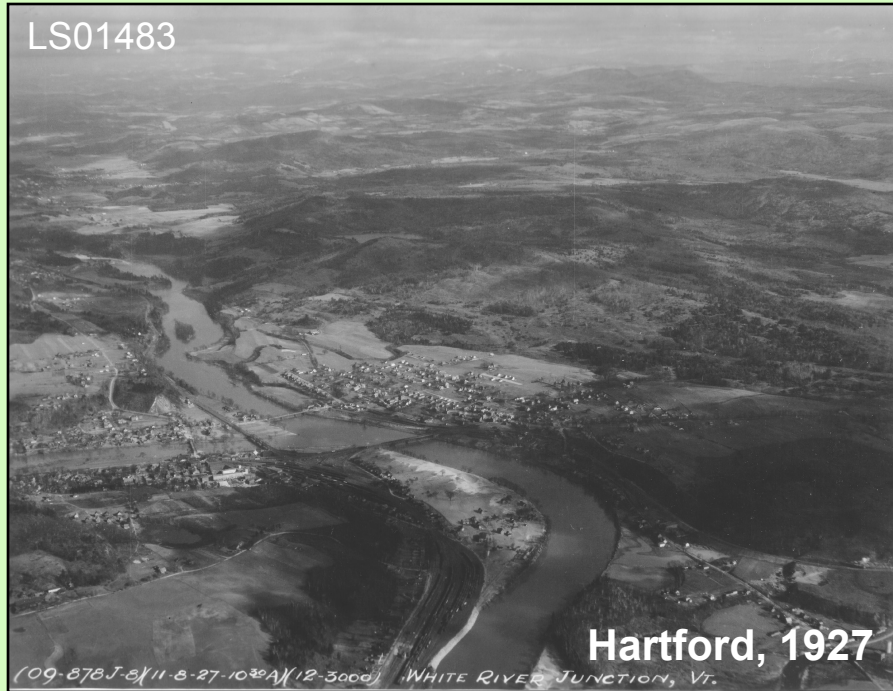
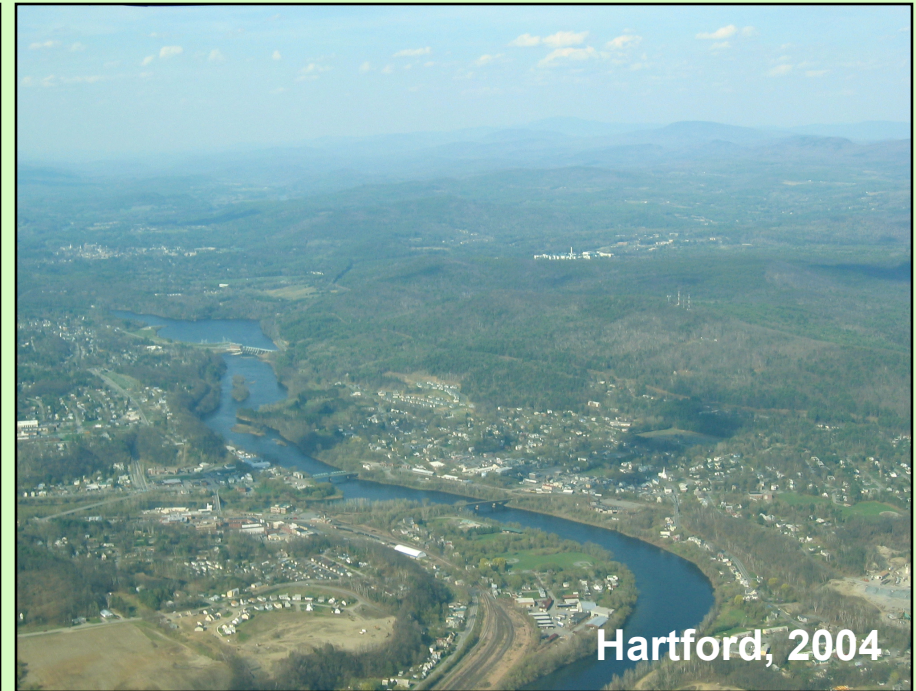
Riparian Vegetation

Almost all rivers in Vermont have shown an increase in riparian vegetation over the past 20 years. This photo pair shows the riparian corridor along the Connecticut River (White river at left).

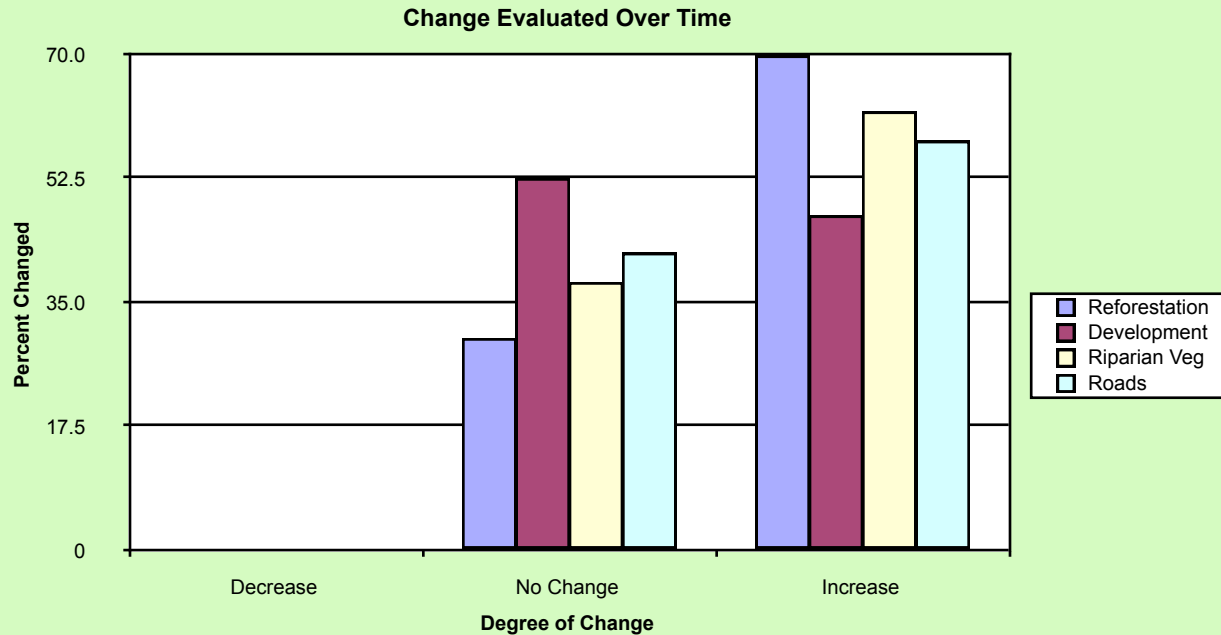
Evaluation of Change

The graph above shows the general trends of forestation, development, riparian vegetation, and road building over the last 77 years in Vermont. None of the photos showed a decrease in any of the categories. The greatest increase is seen in forestation and the least increase in development.

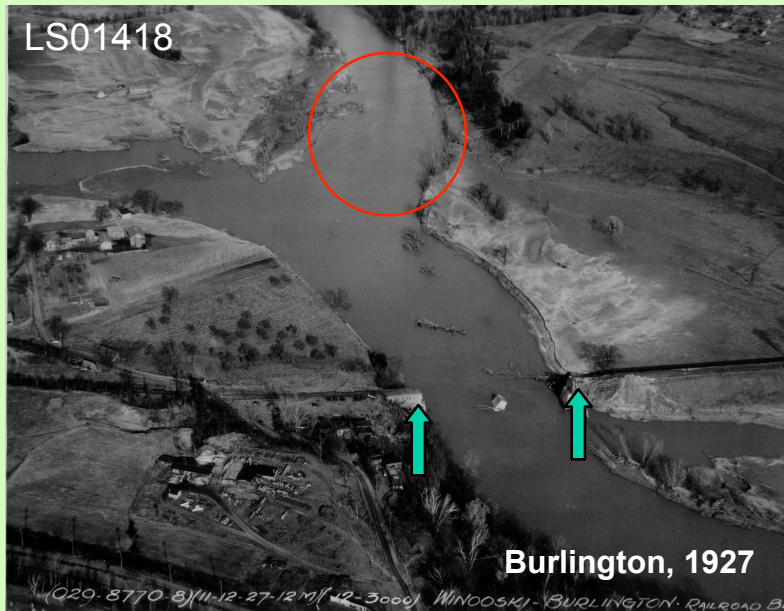
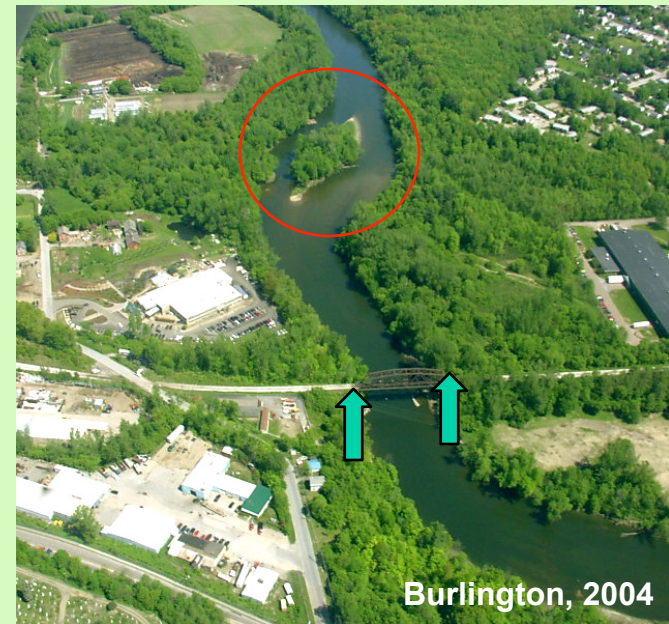
The pair that started it all. Note the dramatic narrowing in channel width and the appearance of a mid-channel island along the Winooski River.

After comparing the historic aerial photographs to their current counterparts, we noticed a marked change in channel width between a few image pairs. It seemed that by using sequential historic aerial photographs we would be able to gain a better understanding of the change the channel has undergone in the past 100+ years.

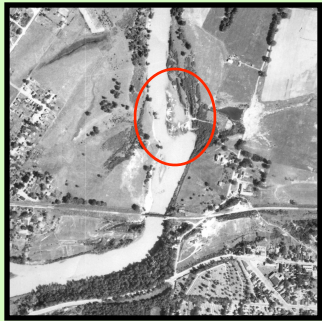
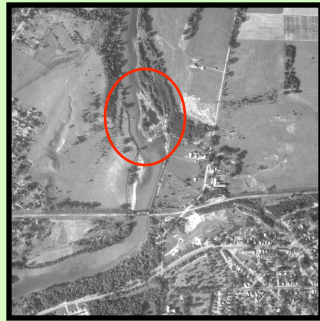
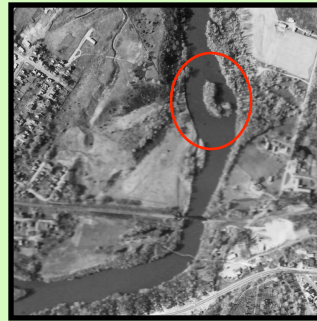
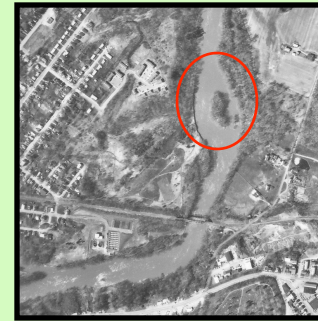
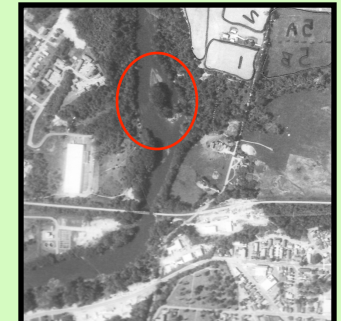
Historical Aerial Photos

Aerial photos of Winooski River showing change in channel width and development of mid-channel island. These photos were used to calculate channel change and island development over time. (See graphs later in show) Photos from Natural Resource Conservation Service.

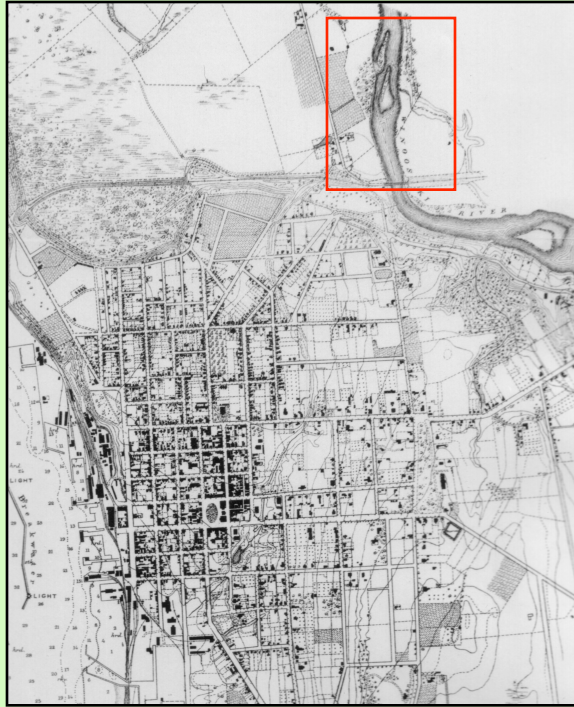
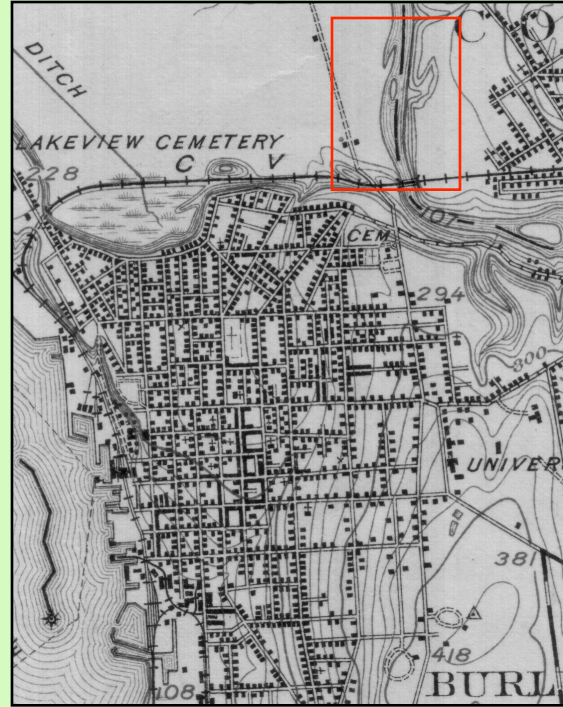
Three maps showing the field area described above. All three maps show a mid-channel island, indicating that the flood of 1927 completely removed the island. 1906 and 1948 maps 1:62,000.

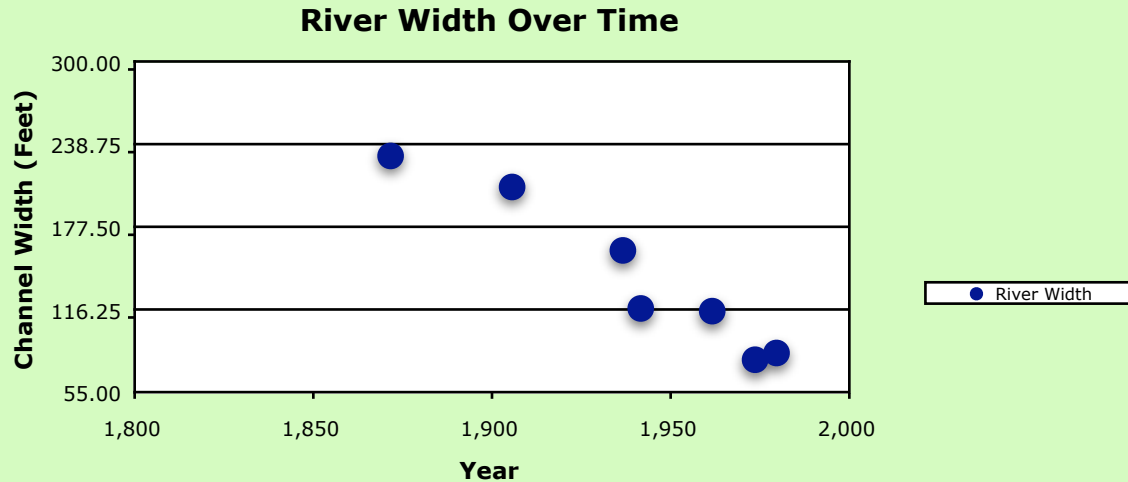
Results: Channel Change

- Using historic maps and aerial photographs we were able to calculate river width for seven different times.
- Channel width steadily decreased over time.
- Change in channel width is possibly due to deforestation throughout the state in the 1800s that supplied large amounts of sediment to the rivers.
- The rise in sediment yield forced the rivers to aggrade, thus creating a wider river. The increase in forestation over the past 100 years has allowed the river to narrow and incise into the sediment.

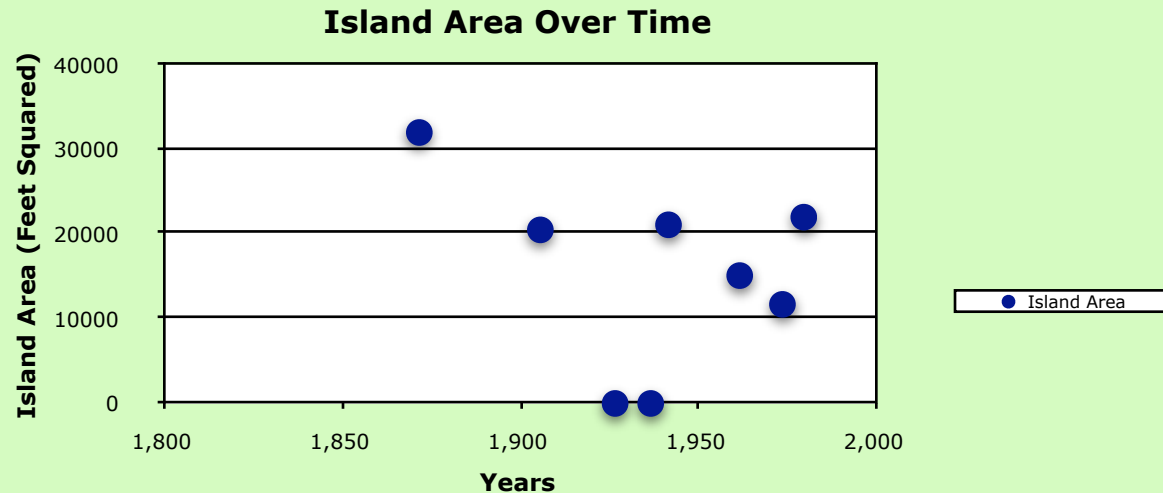
Results: Island Area

- Island area has fluctuated over time.
- The 1927 flood appears to have obliterated the island, so much that by 1937, 10 years later, the island is still not exposed.
- The general trend shows a rapid decrease in island area due to the 1927 flood. The island then gains size over time, degrading once again between 1942 and 1974, possibly due to greater river incision rates.
